## **TAMU Project**

**Energy Consumption Data Quality Assurance/Quality  
Control Assessment Report for the  
Month of October 2017**

**Utility & Energy Services  
Division of Administration  
Texas A&M University**

**November 2017**

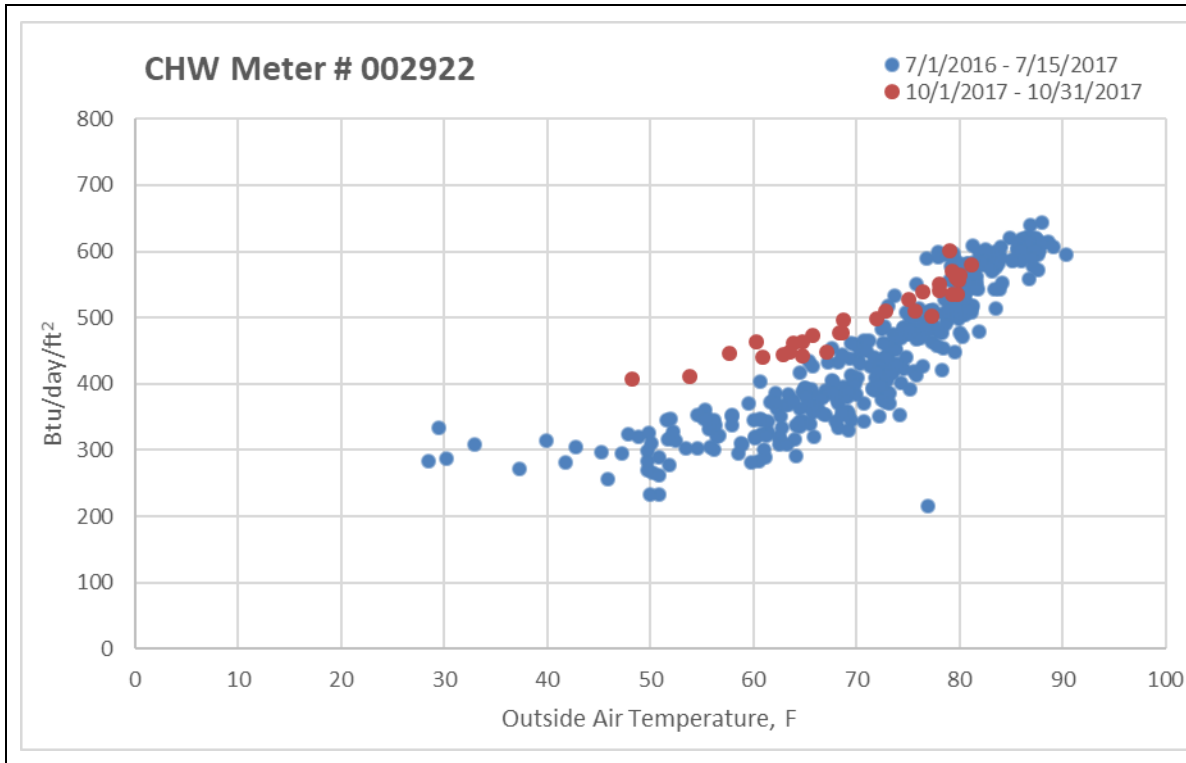
***Explanatory Figure: Scatter plot of CHW Meter #002922 versus outside air temperature showing the pattern before and after 10/1/2017.***

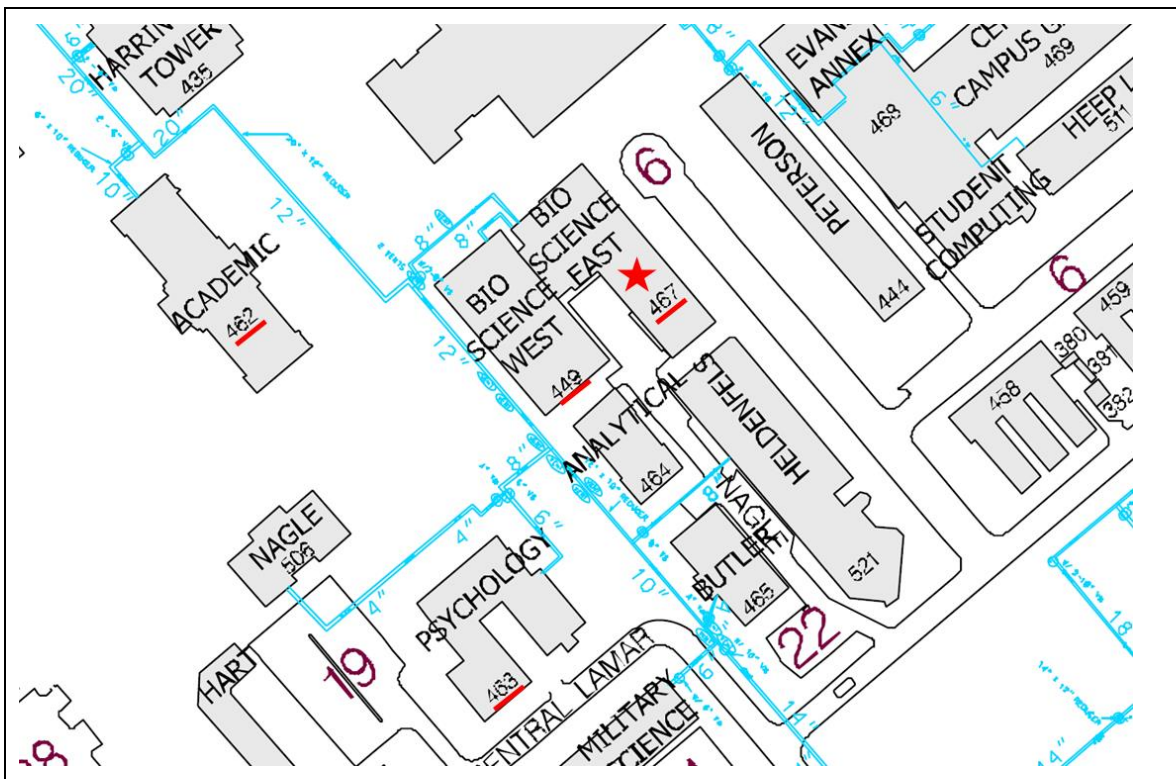
**Explanatory Figure: CHW distribution with Bldgs. #467 Biological Sciences East, #462 Academic, #449 Biological Sciences West, and #463 Psychology highlighted.**

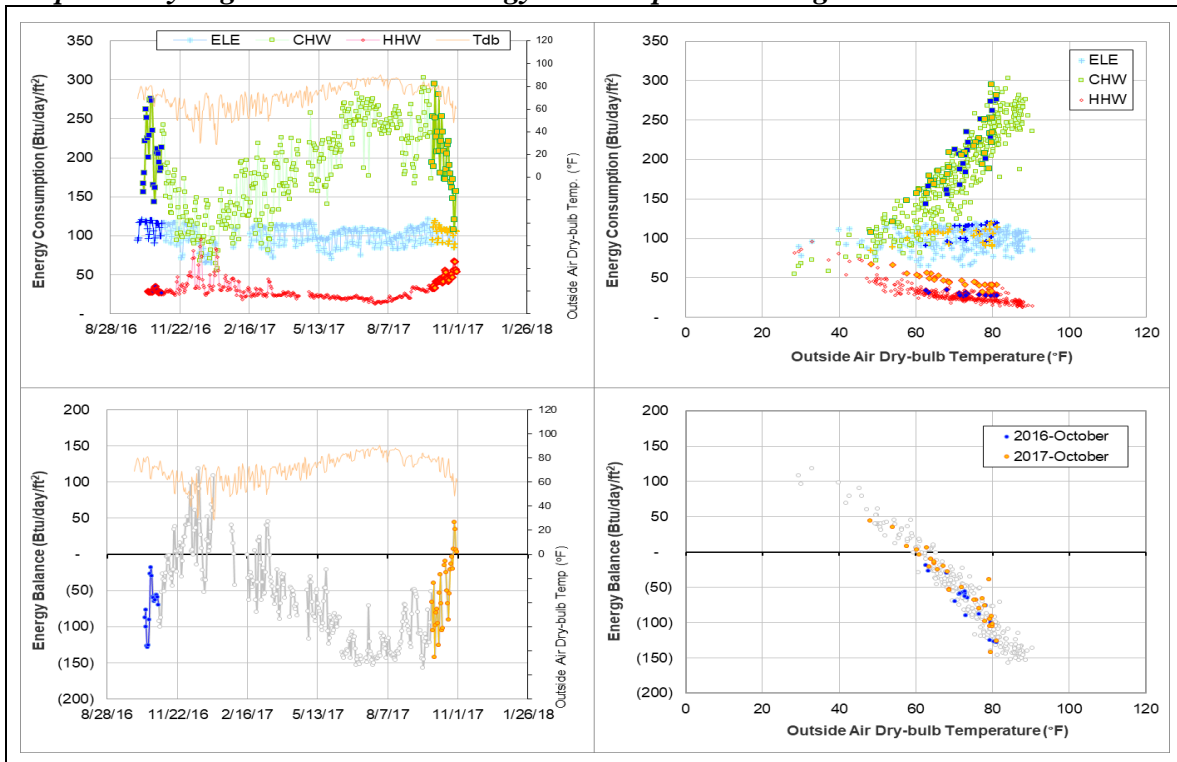
### Explanatory Figure: 13 months energy balance plot with original data

Evans Library has five HHW meters. Starting 9/5/2017, HHW meter #003712 experienced an increase in flow rate from about 15 gpm to 50-60 gpm. This caused consumption level to increase three times larger than the normal pattern (an overall increase of 8 mmBtu/day). In August 2017, before the increase, HHW meter #003217 accounted for only 26% of the total HHW consumption. Now, in October 2017, it accounts for 58% of the total. The HHW consumption for this meter was estimated by model for this month.

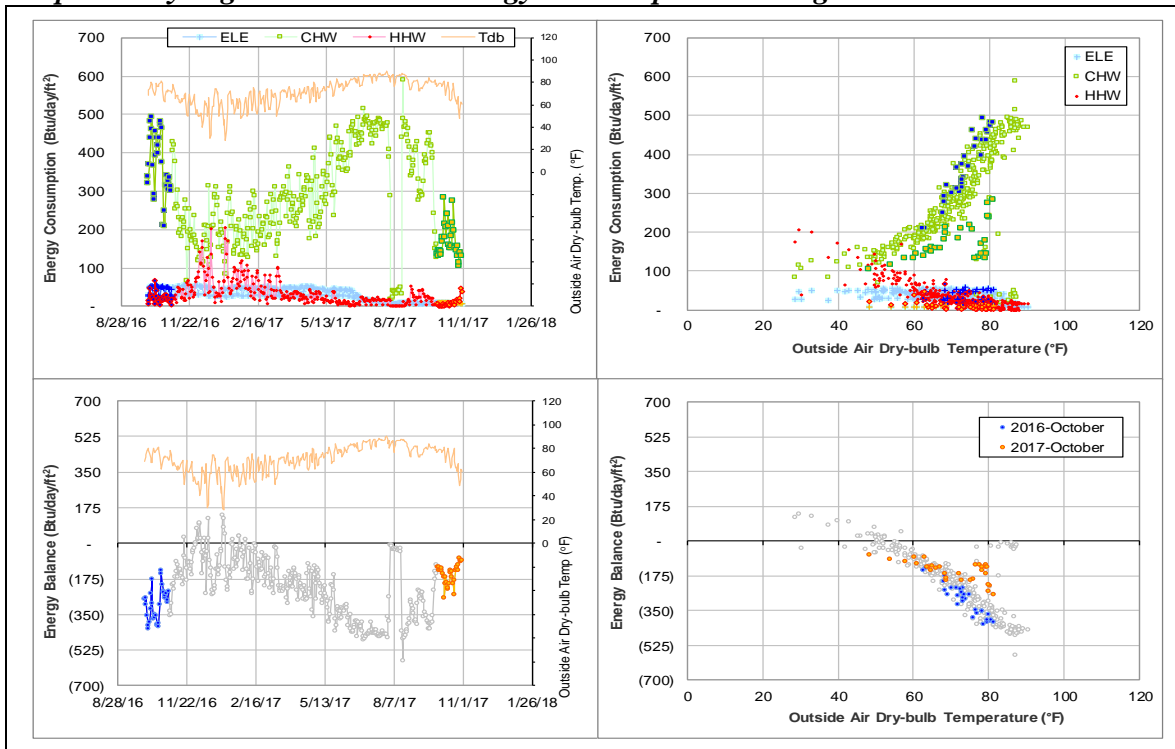
### Explanatory Figure: 13 months energy balance plot with original data.

An incident of central plant outage on 9/26/2017 caused disturbance to this building and CHW of this building did not recover immediately after the incident was resolved. CHW flow rate decreased from 100 – 140 gpm to 20 – 40 gpm during the plant outage and remained low after the incident. The consumption then recovered to 80 – 120 gpm on 10/9/2017. The latter part is not suspected to be a continued problem. The affected days are estimated by model. See also II-3.

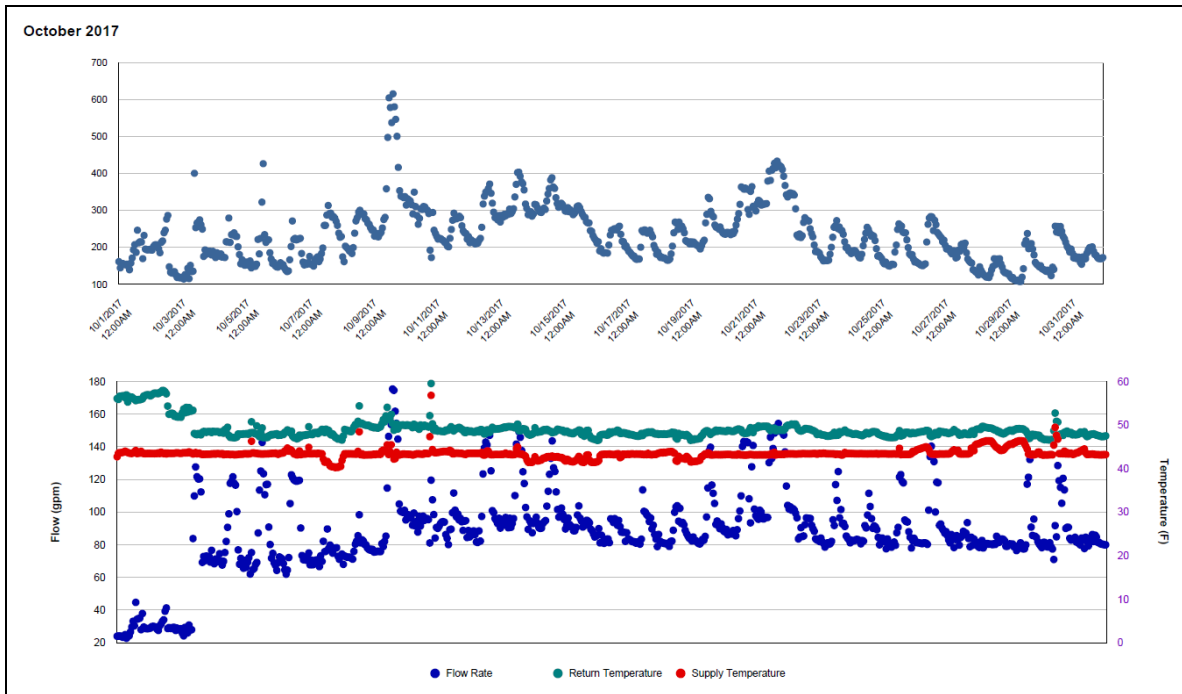
*Explanatory Figure: Time series plots of hourly energy consumption, flow rate, and supply and return temperatures from the utilities office. (CHW during October 2017)*

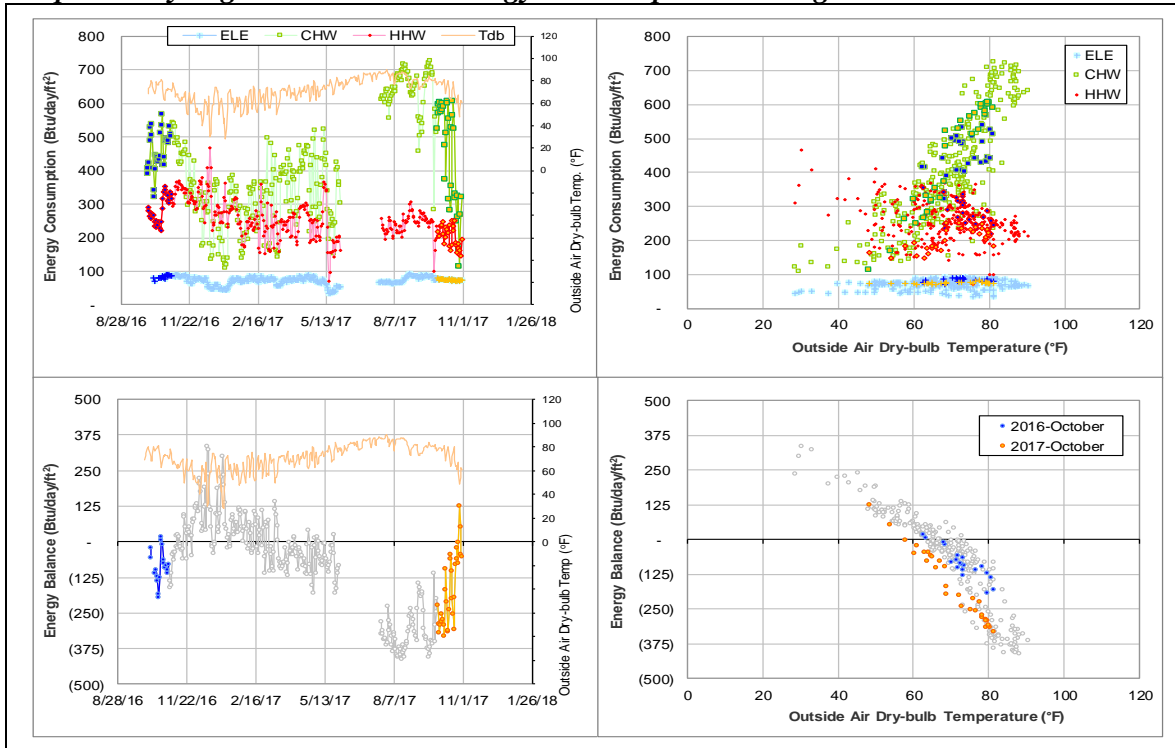
### Explanatory Figure: 13 months energy balance plot with original data.

HHW flow rate decreased on 9/26/2017 which may have been caused by the plant outage. The flow rate is recovering gradually back to the normal level but is still low. The supply and return temperatures of HHW have been fluctuating after the incident. The affected days are estimated by model.

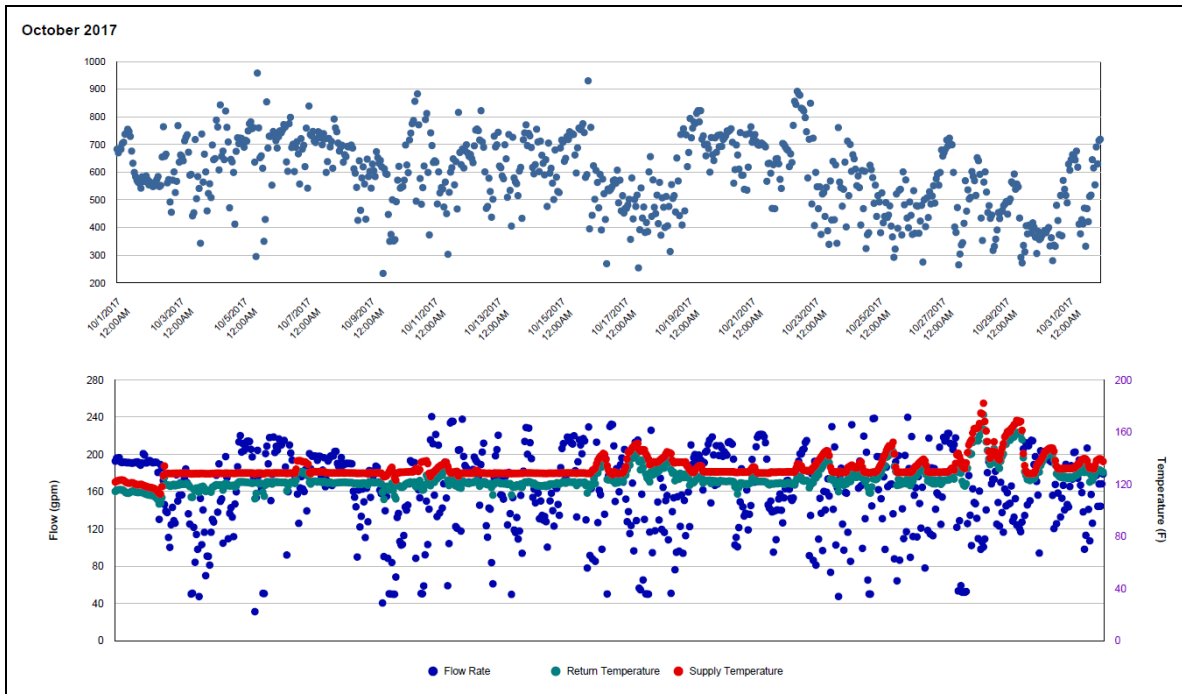
*Explanatory Figure: Time series plots of hourly energy consumption, flow rate, and supply and return temperatures from the utilities office. (HHW during October 2017)*

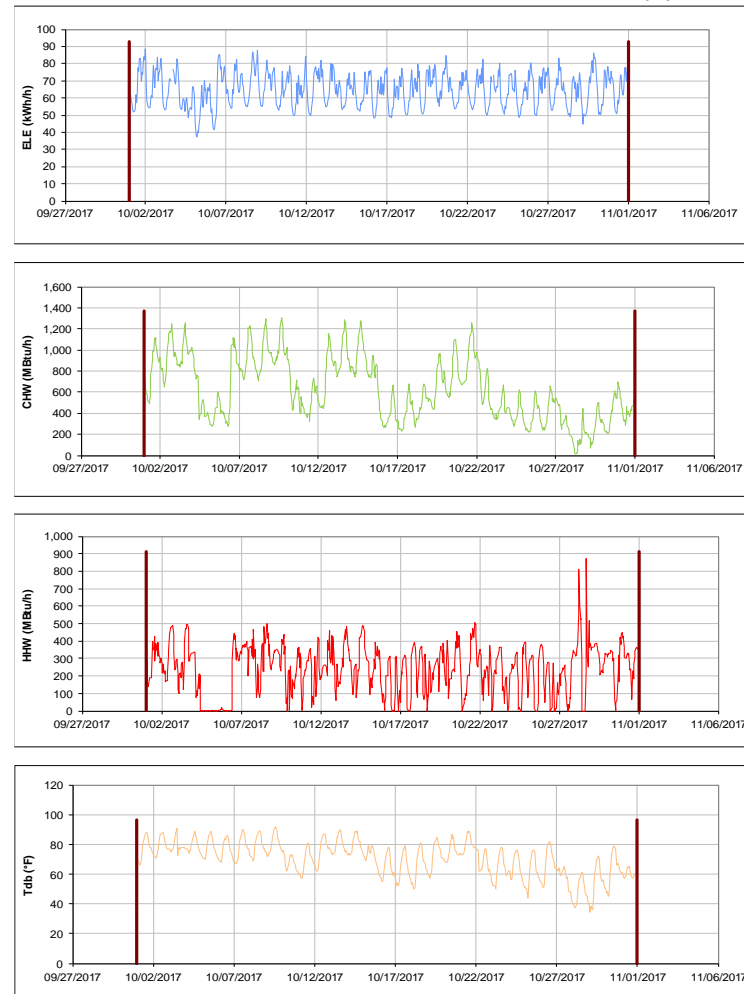
TAMU / BLDG #: 0291

Figure III-4 Hourly Whole Building Electricity, Chilled Water, and Hot Water Consumption for Rudder Residence Hall during the Month of October 2017 and the Corresponding Hourly Outdoor Dry Bulb Temperature for College Station, TX

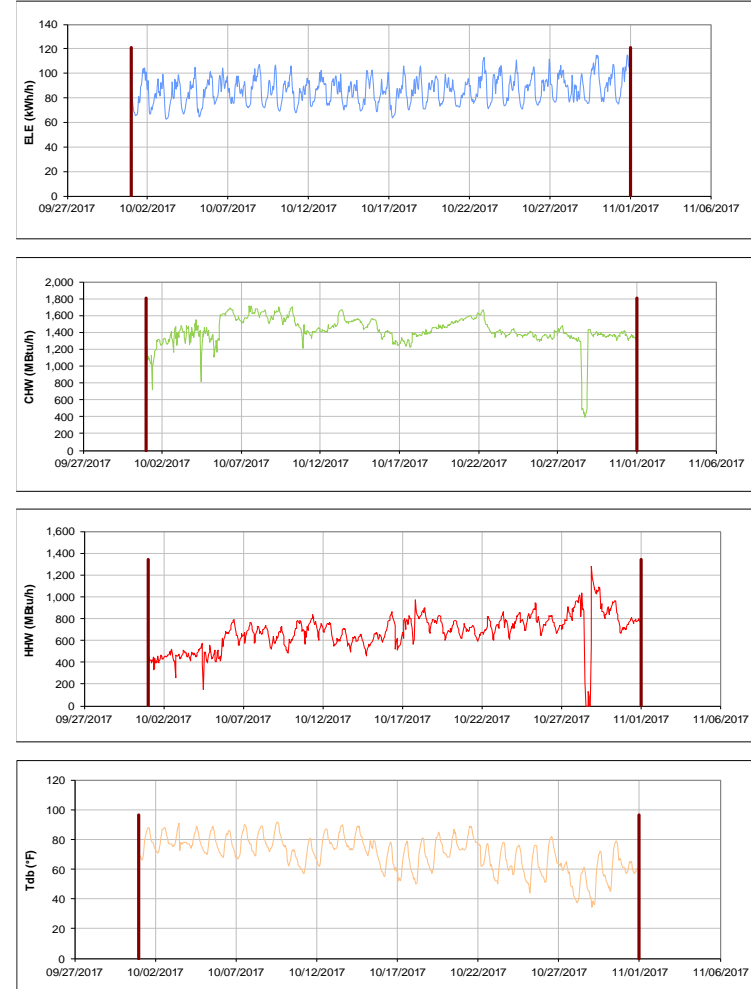
TAMU / BLDG #: 0293

Figure III-6 Hourly Whole Building Electricity, Chilled Water, and Hot Water Consumption for Appelt Residence Hall during the Month of October 2017 and the Corresponding Hourly Outdoor Dry Bulb Temperature for College Station, TX

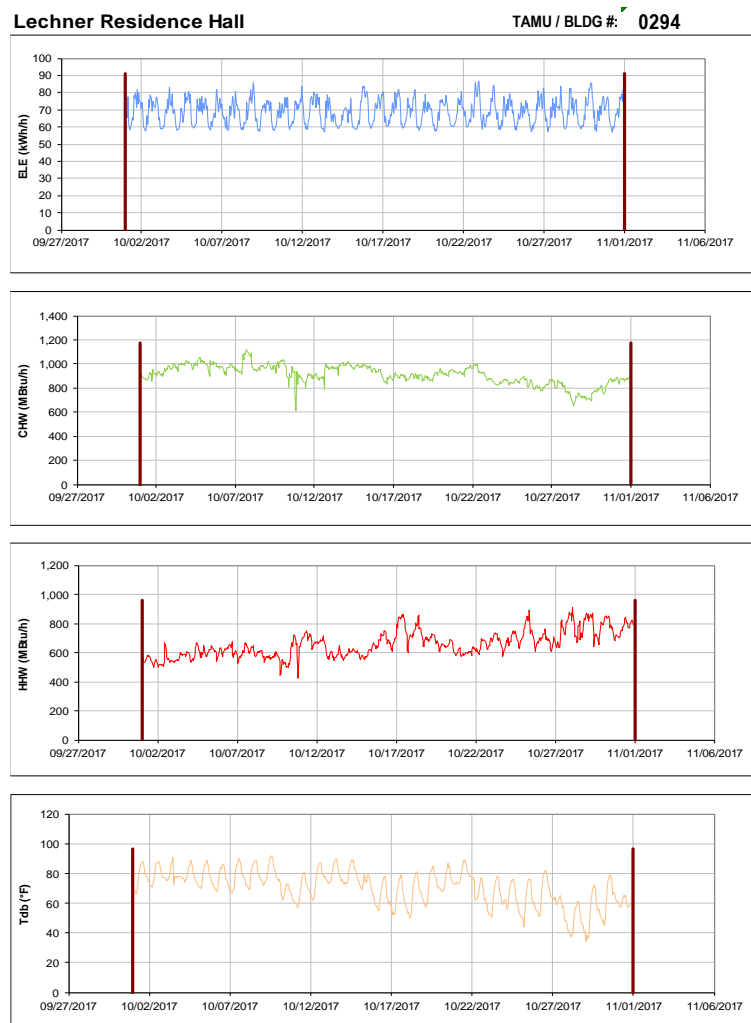
Figure III-7 Hourly Whole Building Electricity, Chilled Water, and Hot Water Consumption for Lechner Residence Hall during the Month of October 2017 and the Corresponding Hourly Outdoor Dry Bulb Temperature for College Station, TX

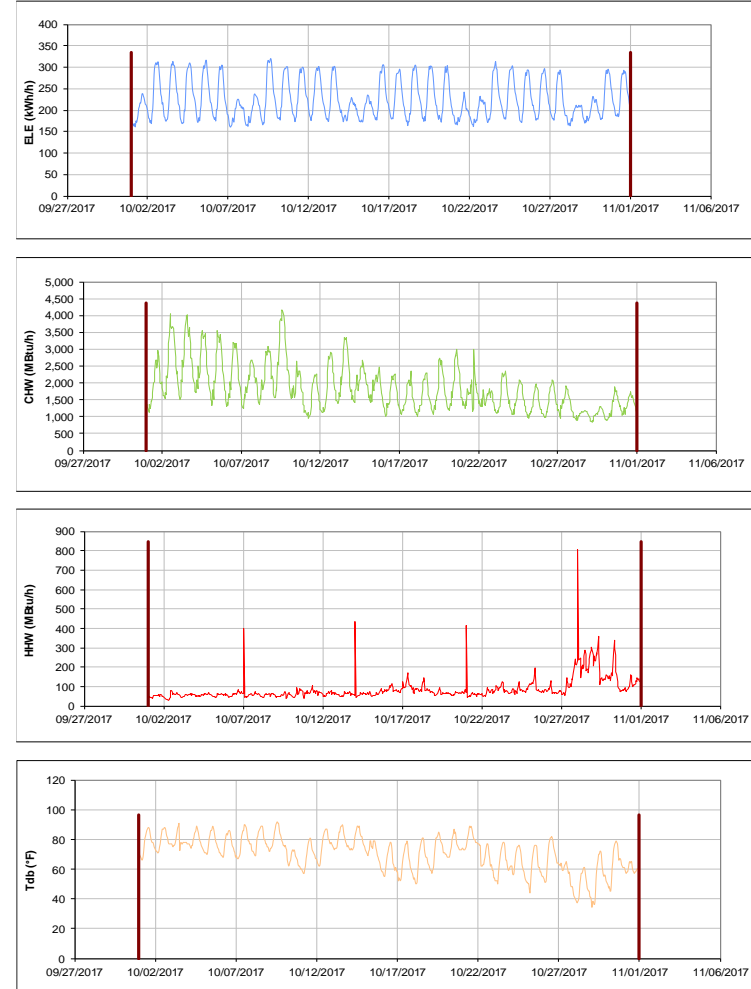
TAMU / BLDG #: 0353

Figure III-10 Hourly Whole Building Electricity, Chilled Water, and Hot Water Consumption for Bright Aerospace Building during the Month of October 2017 and the Corresponding Hourly Outdoor Dry Bulb Temperature for College Station, TX

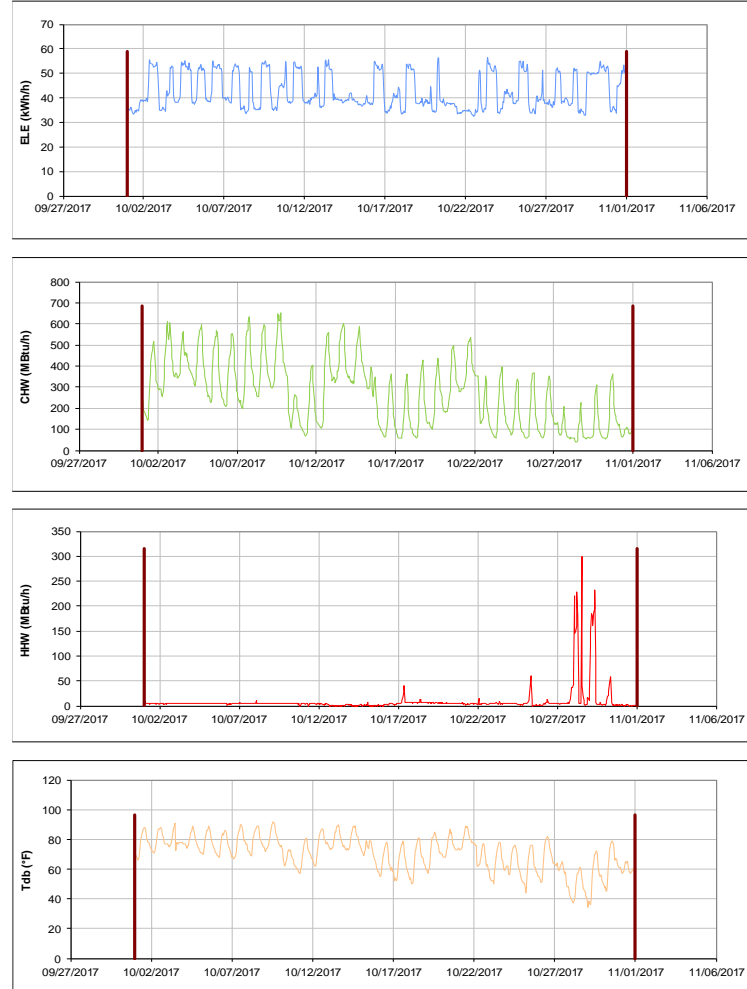
**Davis Football Player Development Center** TAMU / BLDG #: 0358

Figure III-11 Hourly Whole Building Electricity, Chilled Water, and Hot Water Consumption for Davis Football Player Development Center during the Month of October 2017 and the Corresponding Hourly Outdoor Dry Bulb Temperature for College Station, TX

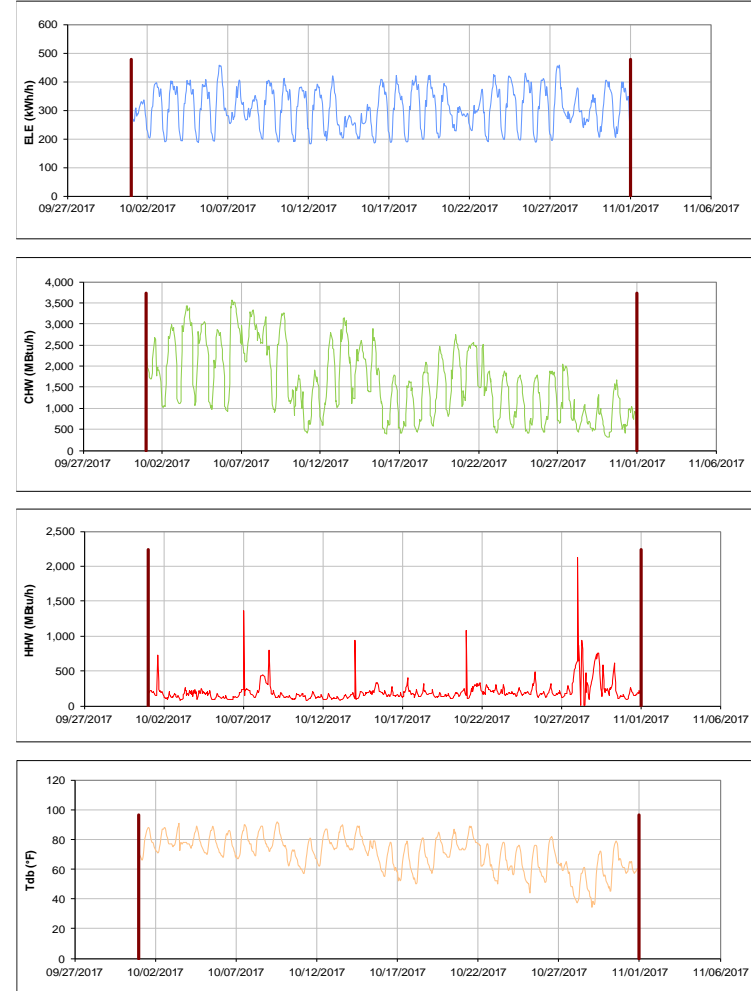
TAMU / BLDG #: 0361

Figure III-14 Hourly Whole Building Electricity, Chilled Water, and Hot Water Consumption for Bright Football Complex during the Month of October 2017 and the Corresponding Hourly Outdoor Dry Bulb Temperature for College Station, TX

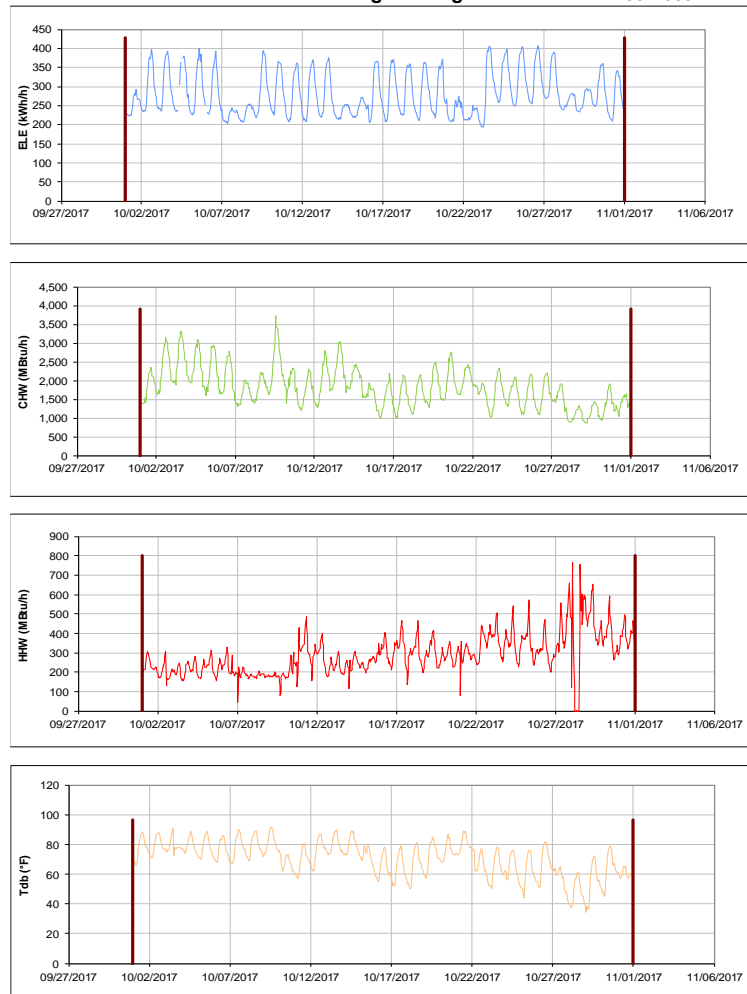
James J. Cain'51 and Mechanical Engineering Office BLDG # 0391-0392

Figure III-21 Hourly Whole Building Electricity, Chilled Water, and Hot Water Consumption for James J. Cain'51 and Mechanical Engineering Office Building during the Month of October 2017 and the Corresponding Hourly Outdoor Dry Bulb Temperature for College Station, TX

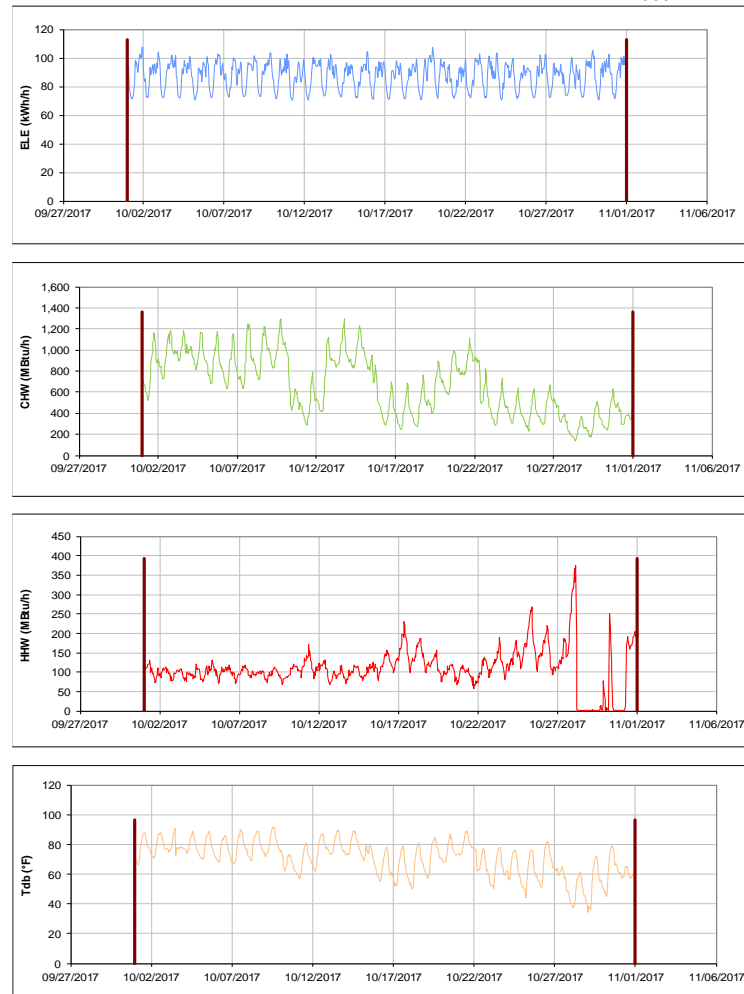
TAMU / BLDG #: 0394

Figure III-22 Hourly Whole Building Electricity, Chilled Water, and Hot Water Consumption for Underwood Residence Hall during the Month of October 2017 and the Corresponding Hourly Outdoor Dry Bulb Temperature for College Station, TX

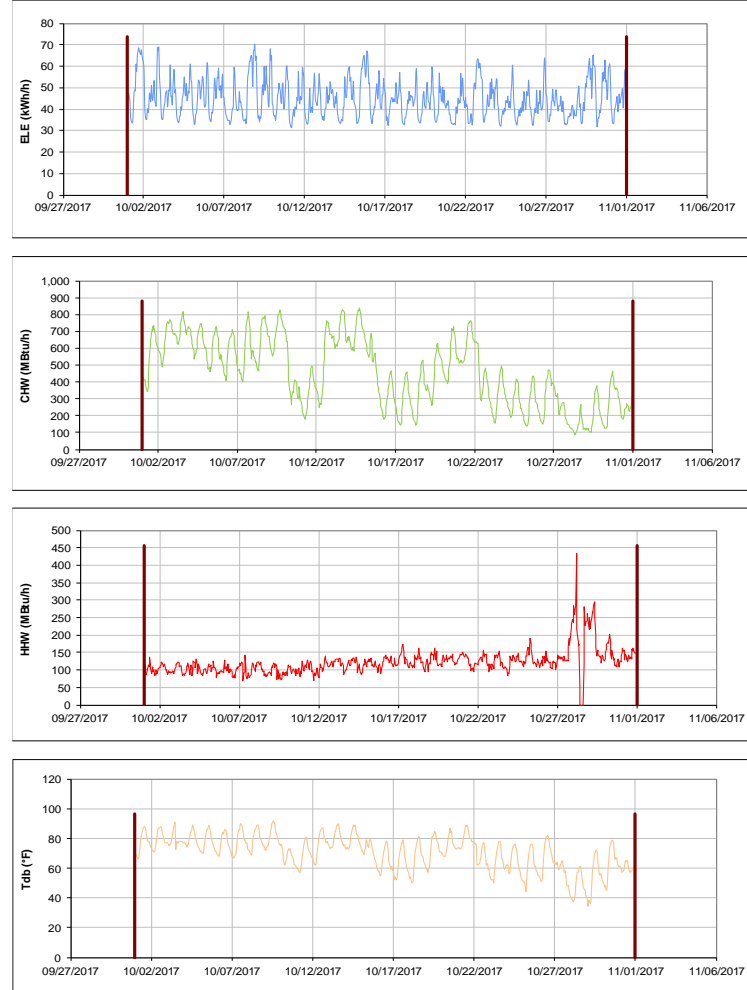
TAMU / BLDG #: 0409

Figure III-37 Hourly Whole Building Electricity, Chilled Water, and Hot Water Consumption for White Hall - Dorm 10 during the Month of October 2017 and the Corresponding Hourly Outdoor Dry Bulb Temperature for College Station, TX

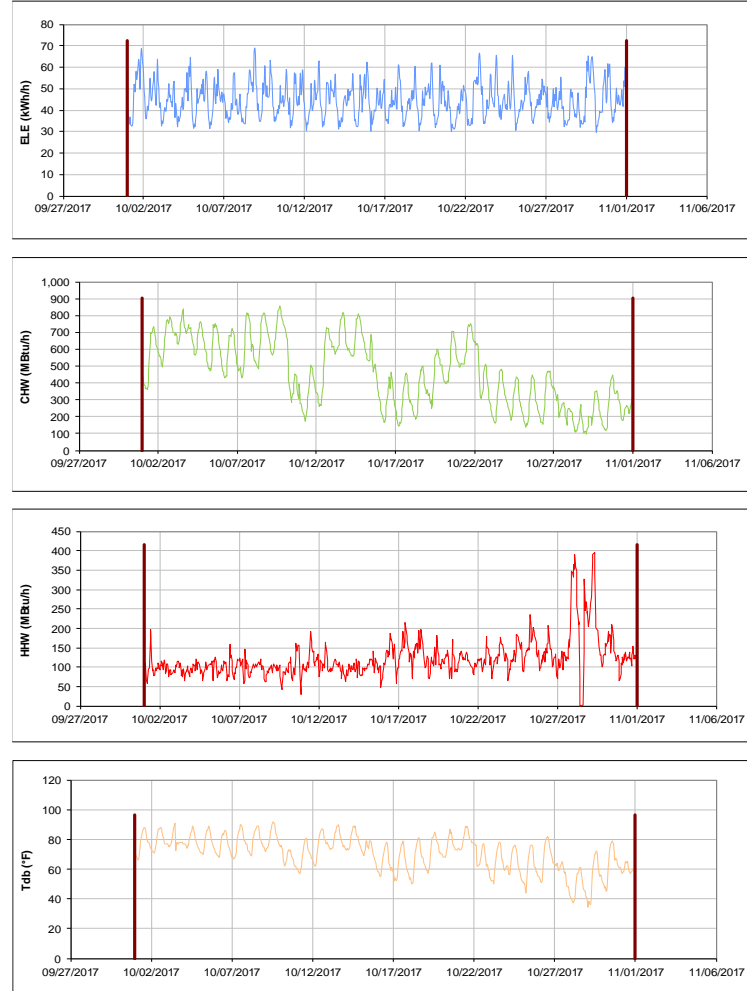
TAMU / BLDG #: 0411

Figure III-39 Hourly Whole Building Electricity, Chilled Water, and Hot Water Consumption for Utay Hall - Dorm 12 during the Month of October 2017 and the Corresponding Hourly Outdoor Dry Bulb Temperature for College Station, TX

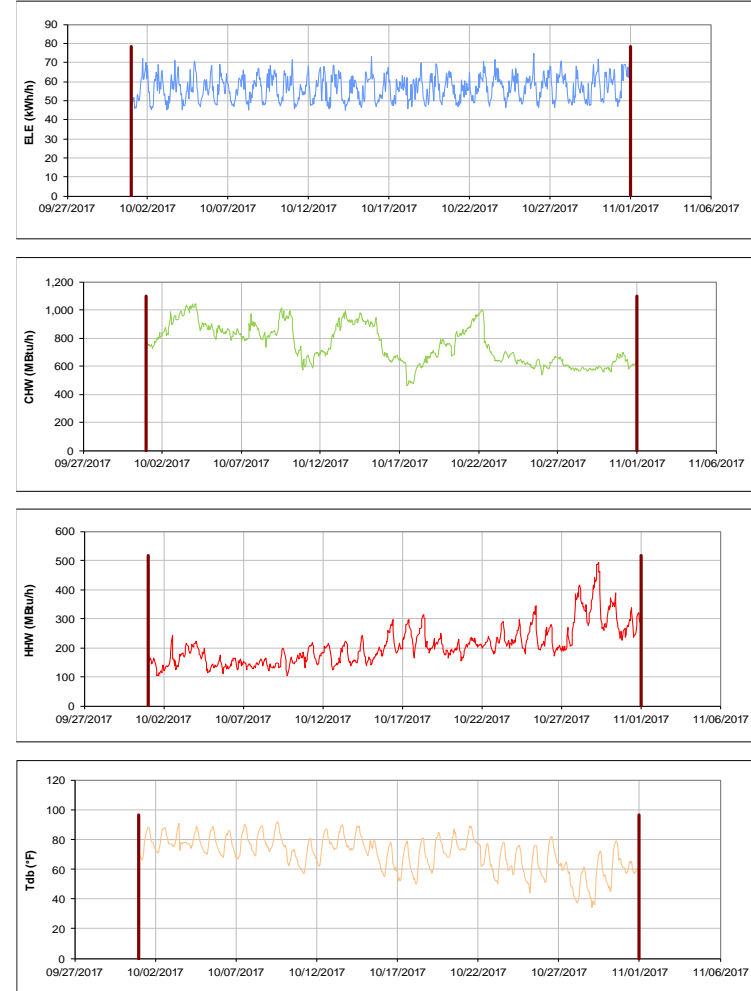
TAMU / BLDG #: 0412

Figure III-40 Hourly Whole Building Electricity, Chilled Water, and Hot Water Consumption for Moses Residence Hall during the Month of October 2017 and the Corresponding Hourly Outdoor Dry Bulb Temperature for College Station, TX

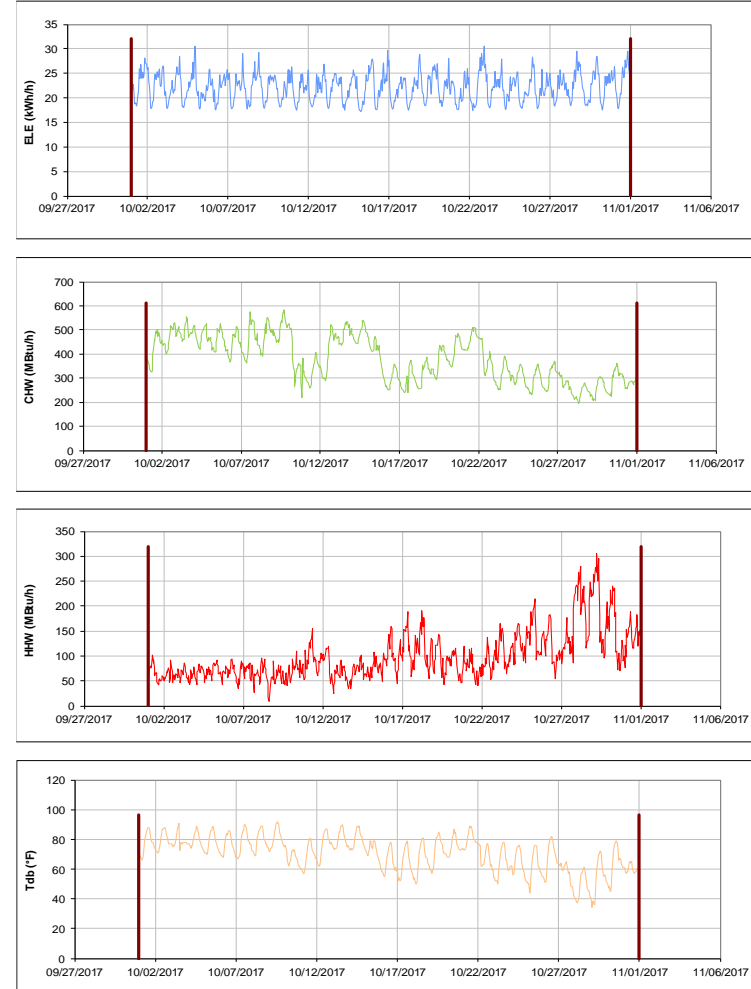
TAMU / BLDG #: 0419

Figure III-42 Hourly Whole Building Electricity, Chilled Water, and Hot Water Consumption for Legett Residence Hall during the Month of October 2017 and the Corresponding Hourly Outdoor Dry Bulb Temperature for College Station, TX

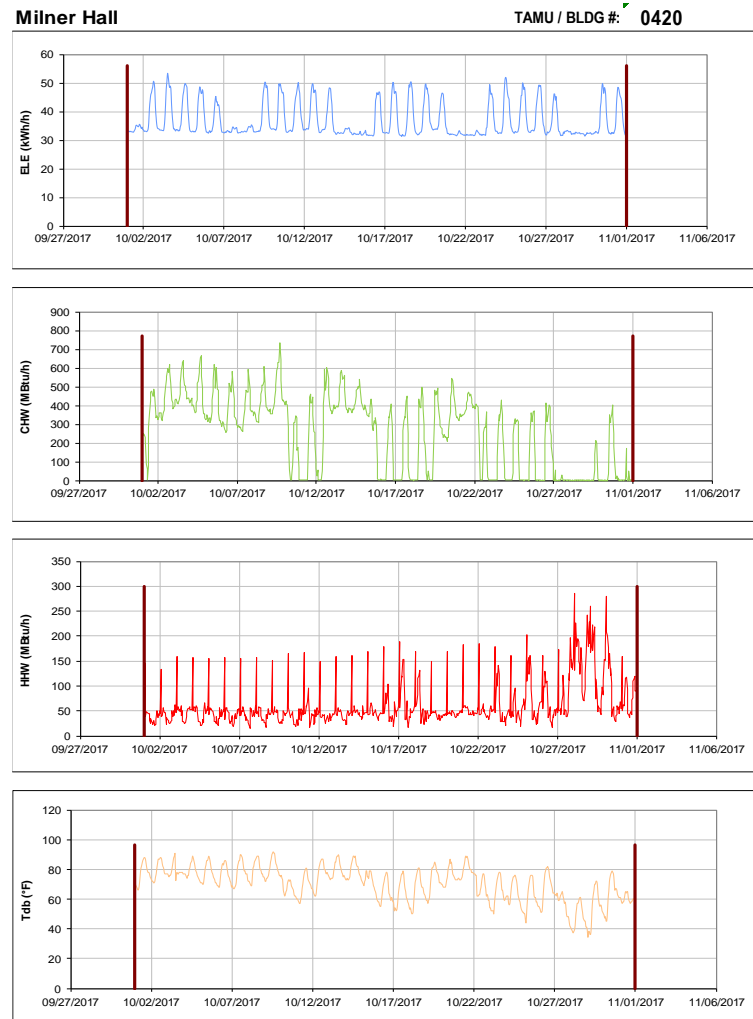
Figure III-43 Hourly Whole Building Electricity, Chilled Water, and Hot Water Consumption for Milner Hall during the Month of October 2017 and the Corresponding Hourly Outdoor Dry Bulb Temperature for College Station, TX

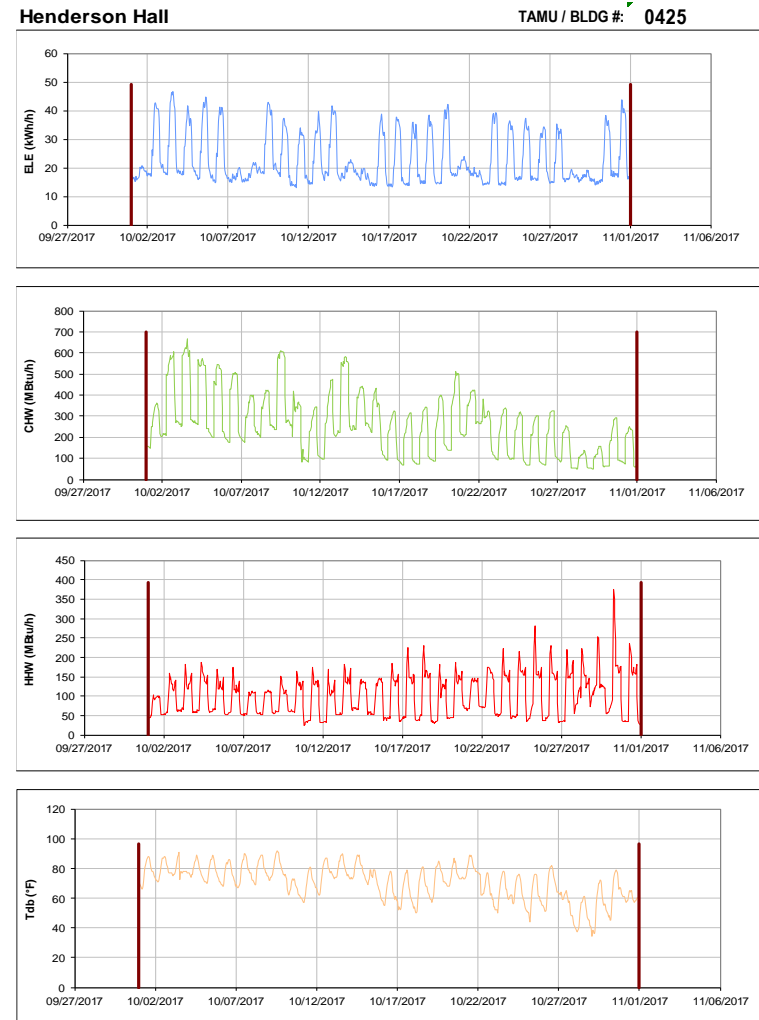
Figure III-46 Hourly Whole Building Electricity, Chilled Water, and Hot Water Consumption for Henderson Hall during the Month of October 2017 and the Corresponding Hourly Outdoor Dry Bulb Temperature for College Station, TX

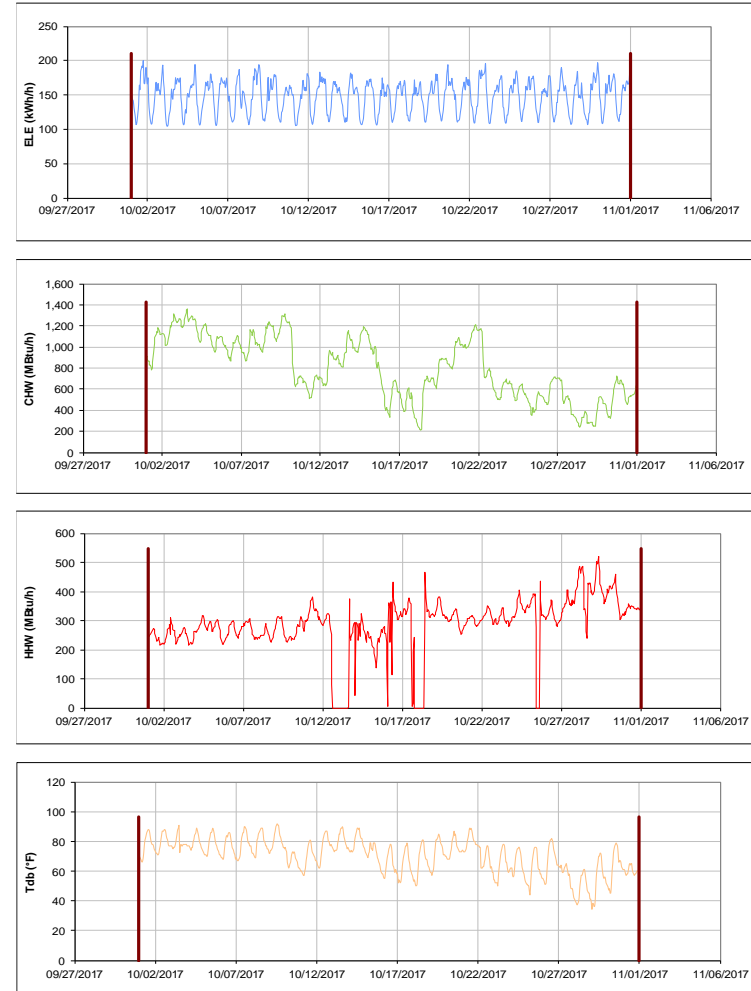
TAMU / BLDG #: 0433

Figure III-50 Hourly Whole Building Electricity, Chilled Water, and Hot Water Consumption for Mosher Residence Hall during the Month of October 2017 and the Corresponding Hourly Outdoor Dry Bulb Temperature for College Station, TX

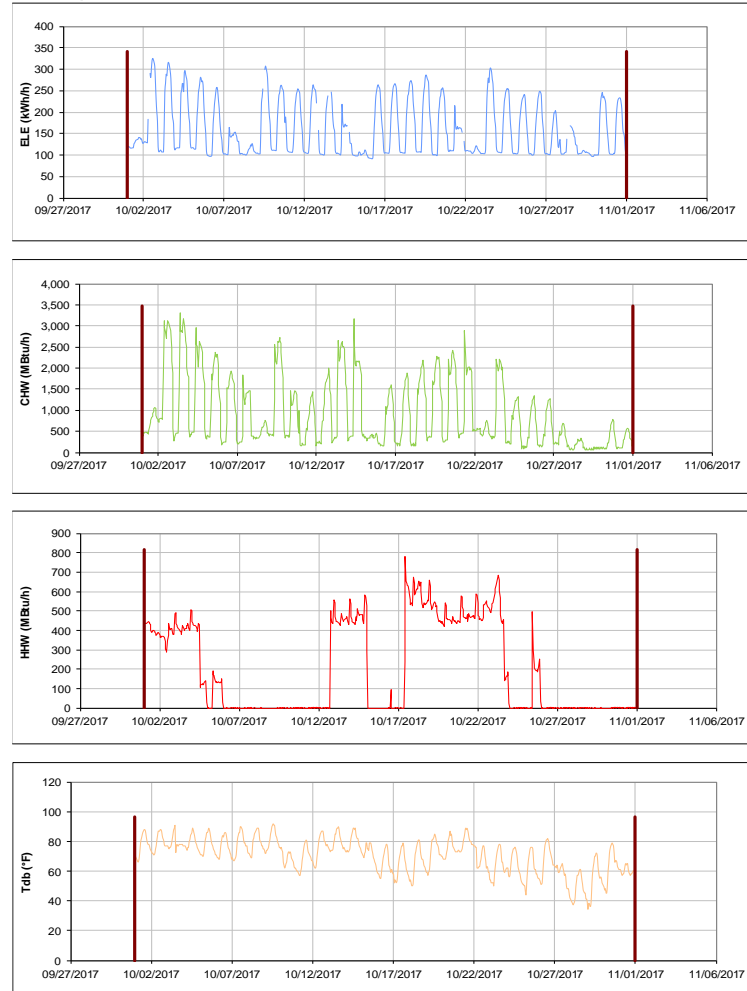
TAMU / BLDG #: 0435

Figure III-53 Hourly Whole Building Electricity, Chilled Water, and Hot Water Consumption for Harrington Education Center Office Tower during the Month of October 2017 and the Corresponding Hourly Outdoor Dry Bulb Temperature for College Station, TX

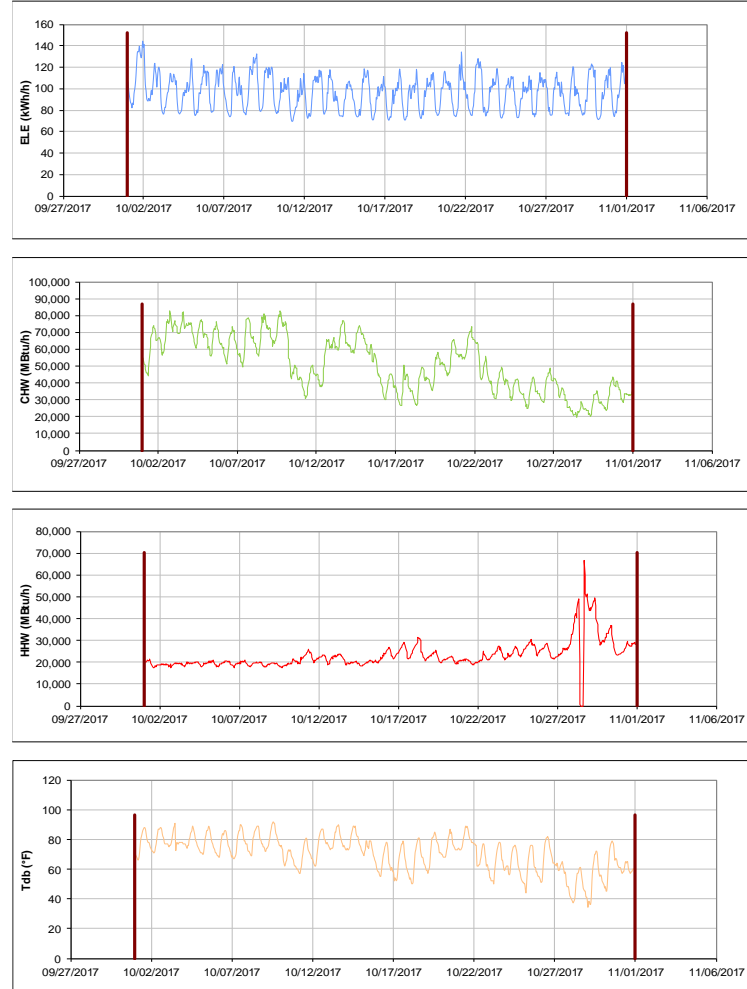
TAMU / BLDG #: 0441

Figure III-59 Hourly Whole Building Electricity, Chilled Water, and Hot Water Consumption for Krueger Residence Hall during the Month of October 2017 and the Corresponding Hourly Outdoor Dry Bulb Temperature for College Station, TX

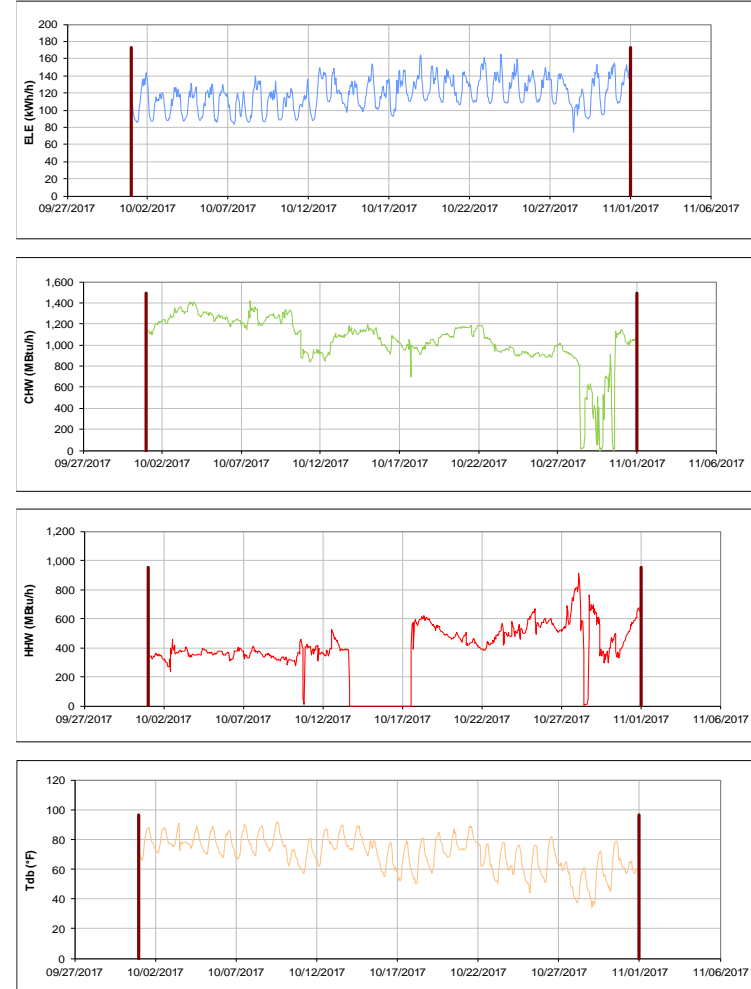
TAMU / BLDG #: 0442

Figure III-60 Hourly Whole Building Electricity, Chilled Water, and Hot Water Consumption for Dunn Residence Hall during the Month of October 2017 and the Corresponding Hourly Outdoor Dry Bulb Temperature for College Station, TX

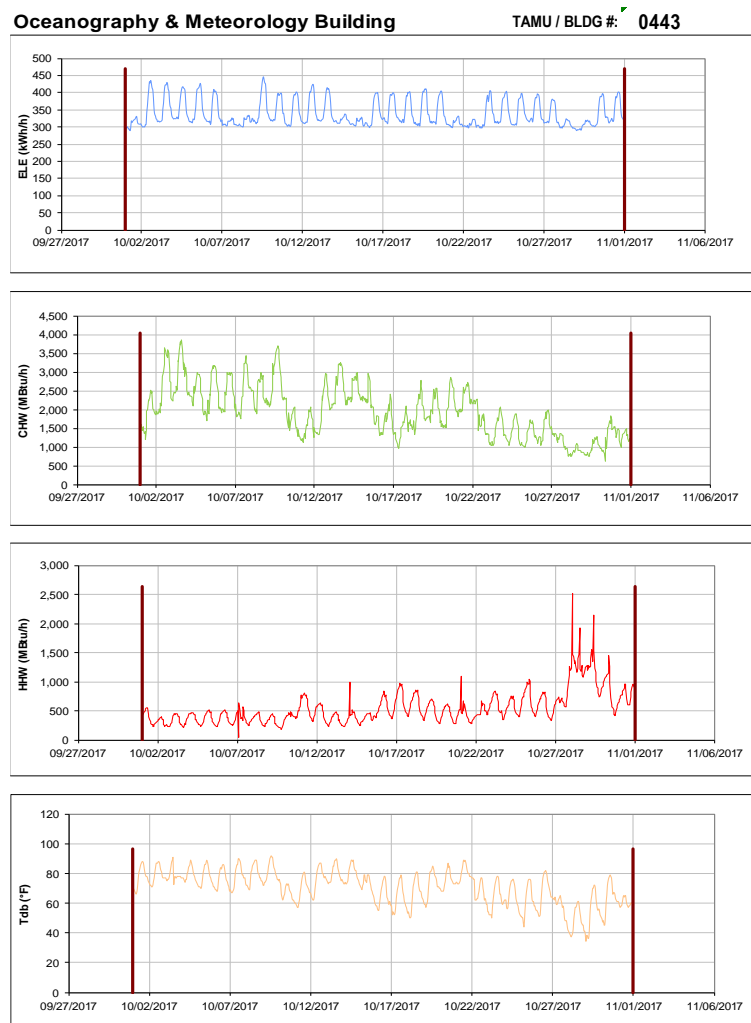
Figure III-61 Hourly Whole Building Electricity, Chilled Water, and Hot Water Consumption for Oceanography & Meteorology Building during the Month of October 2017 and the Corresponding Hourly Outdoor Dry Bulb Temperature for College Station, TX

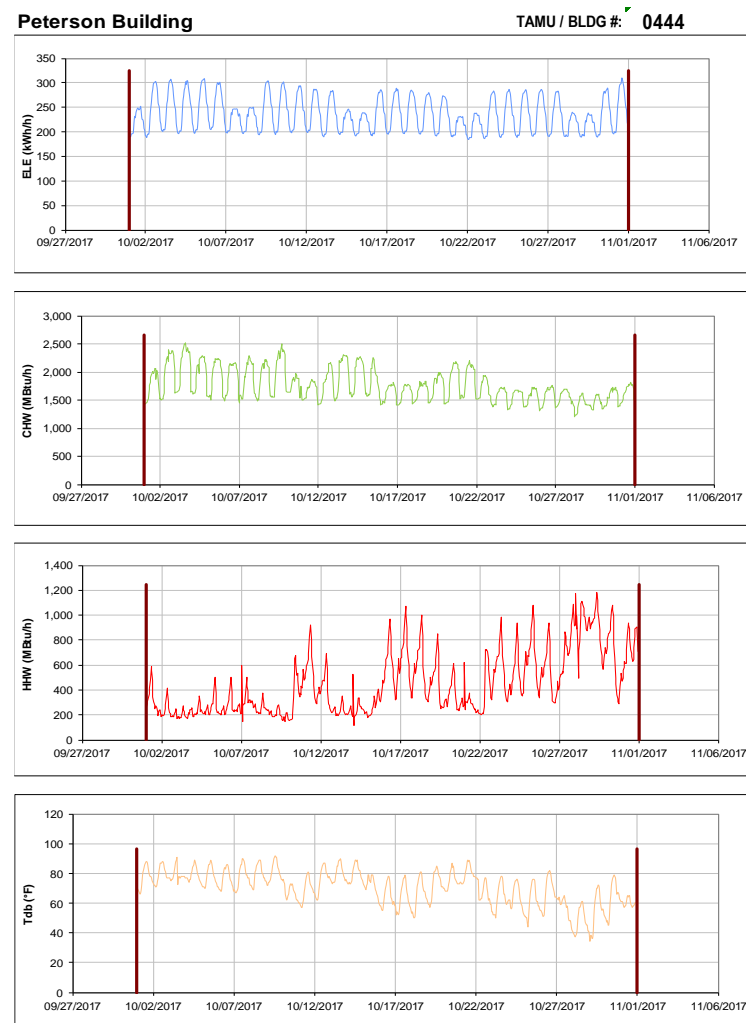
Figure III-62 Hourly Whole Building Electricity, Chilled Water, and Hot Water Consumption for Peterson Building during the Month of October 2017 and the Corresponding Hourly Outdoor Dry Bulb Temperature for College Station, TX
